# Rosemont Marsh Resiliency Plan

**Rosemont Community**  
Charleston, South Carolina

July 2026

**Biohabitats**

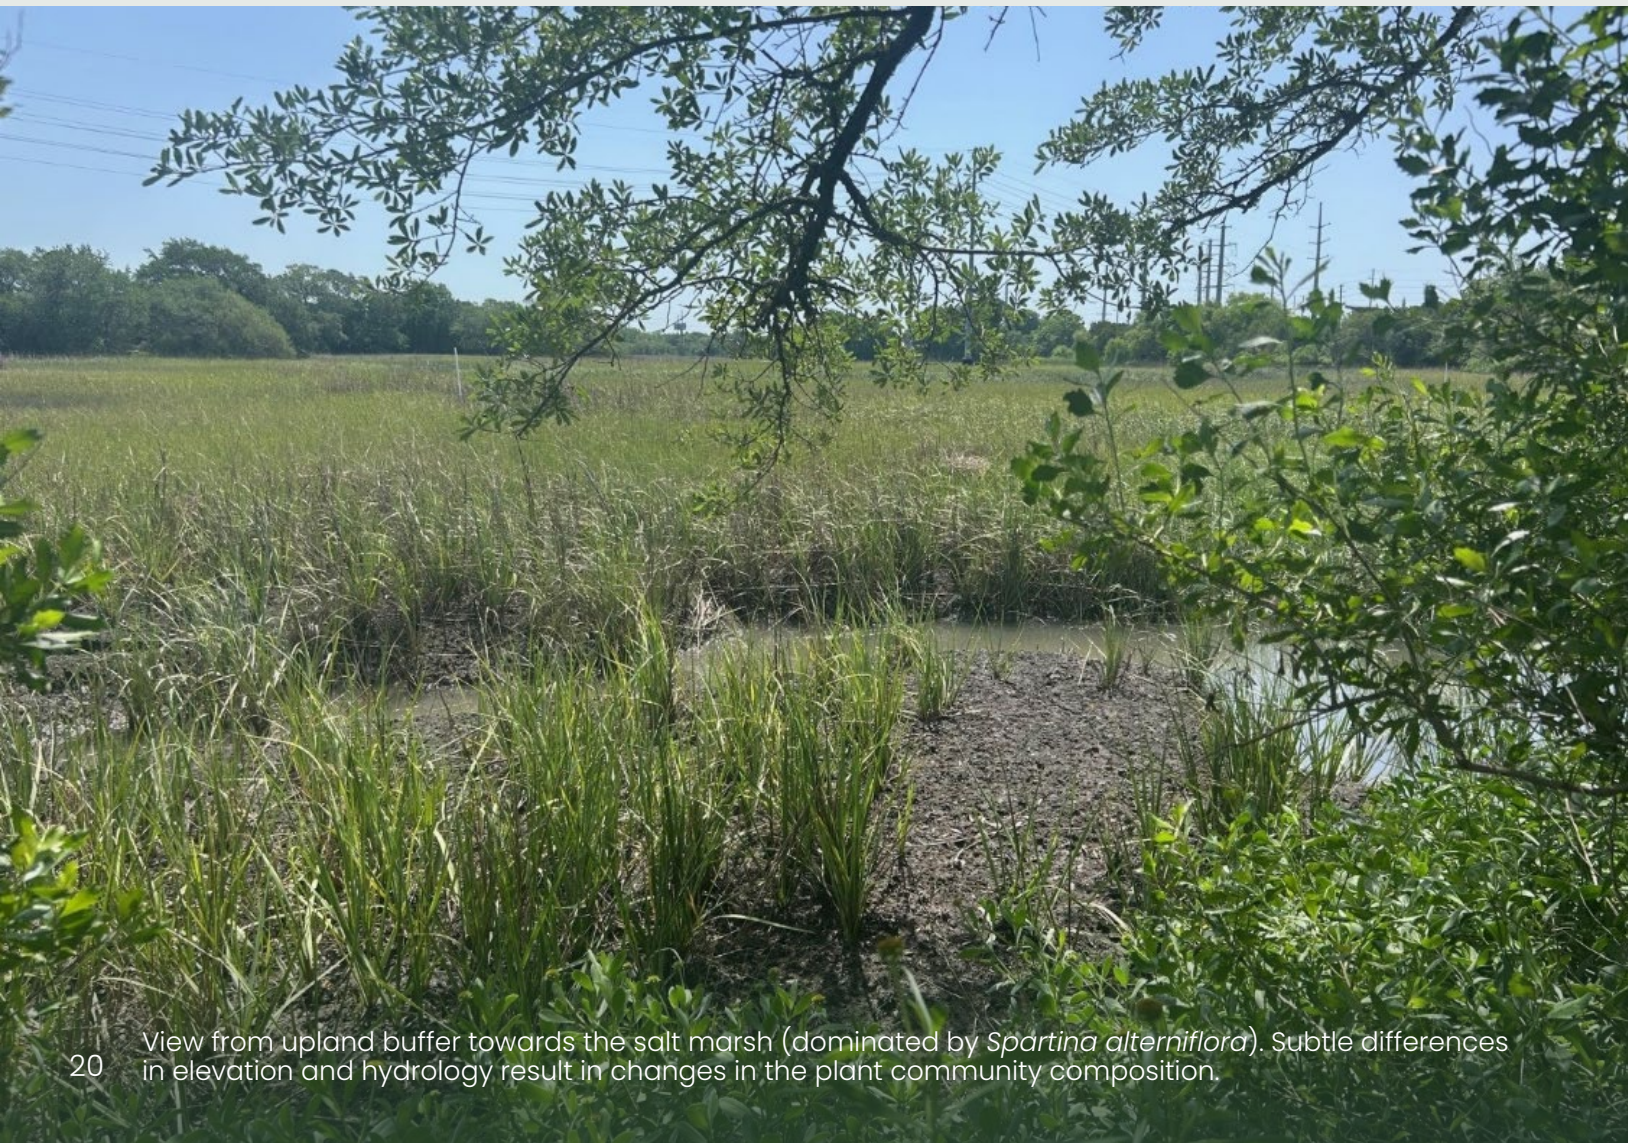
View from upland buffer towards the salt marsh (dominated by *Spartina alterniflora*). Subtle differences in elevation and hydrology result in changes in the plant community composition.

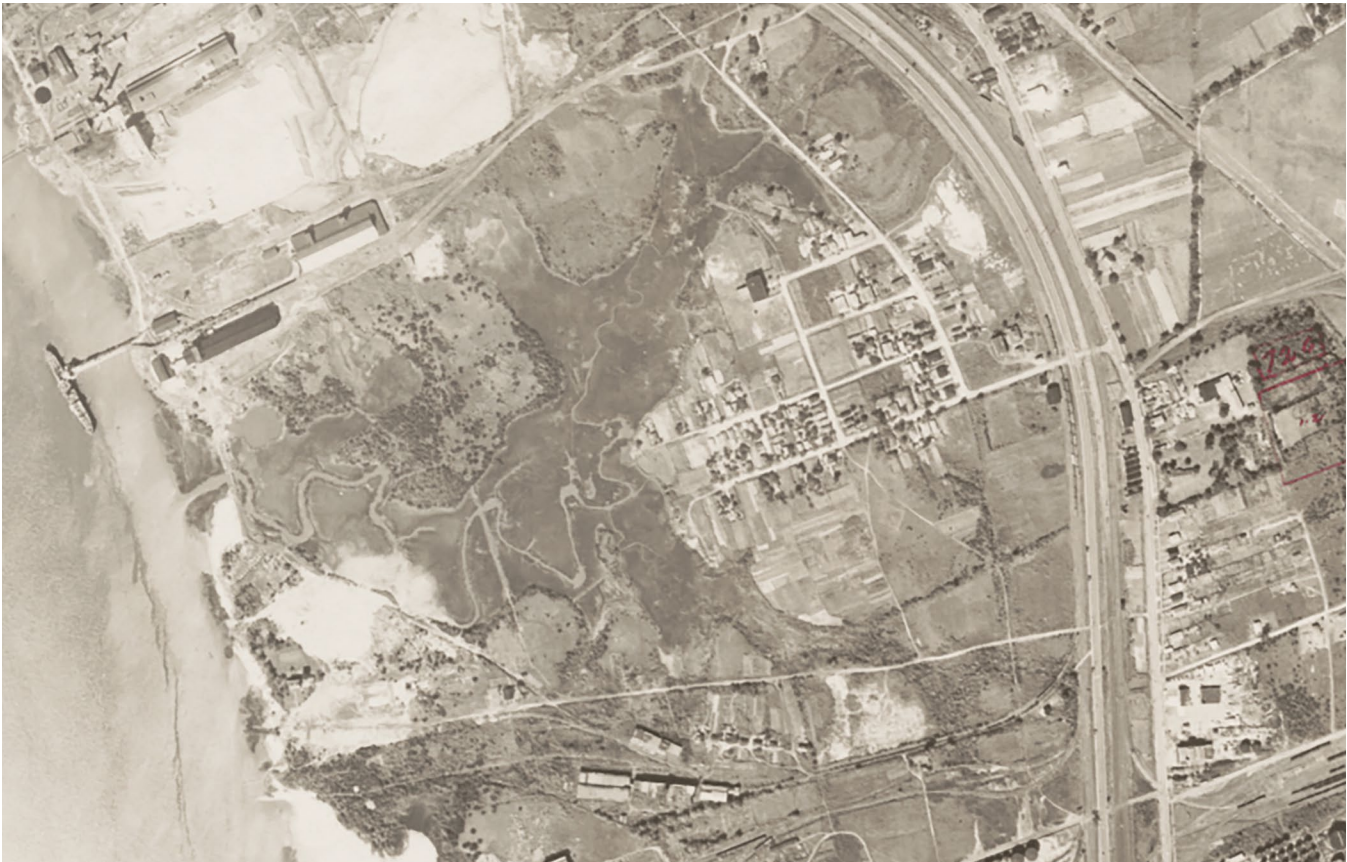
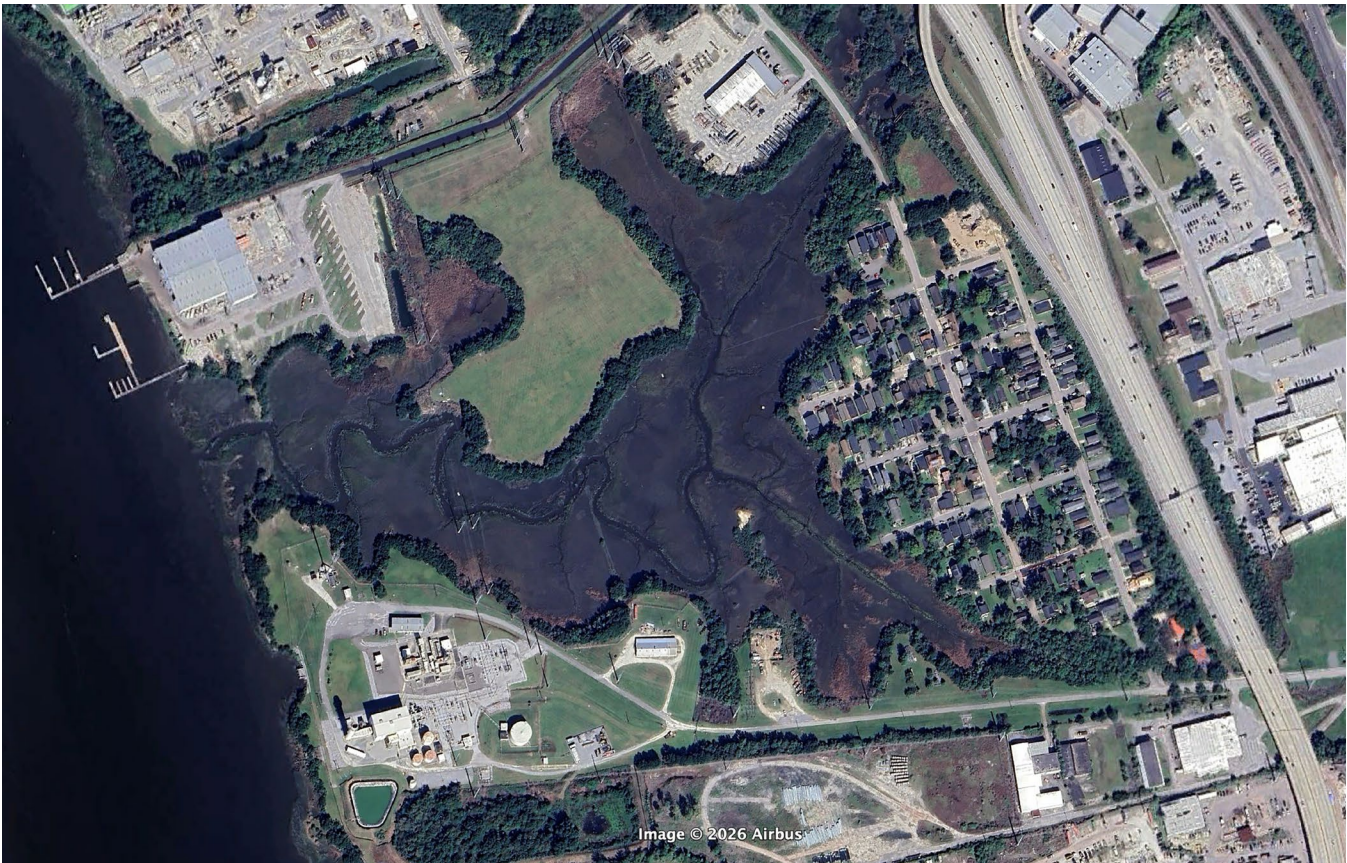
Figure 3: Side by side of Rosemont in 1939 and Rosemont as of November 2025.

Historical aerial imagery dating back to 1939, sourced from the University of South Carolina Libraries aerial photo collection, was reviewed to better understand how the marsh and surrounding landscape have changed through decades of filling, dredging, industrial activity, road construction, and urban development.

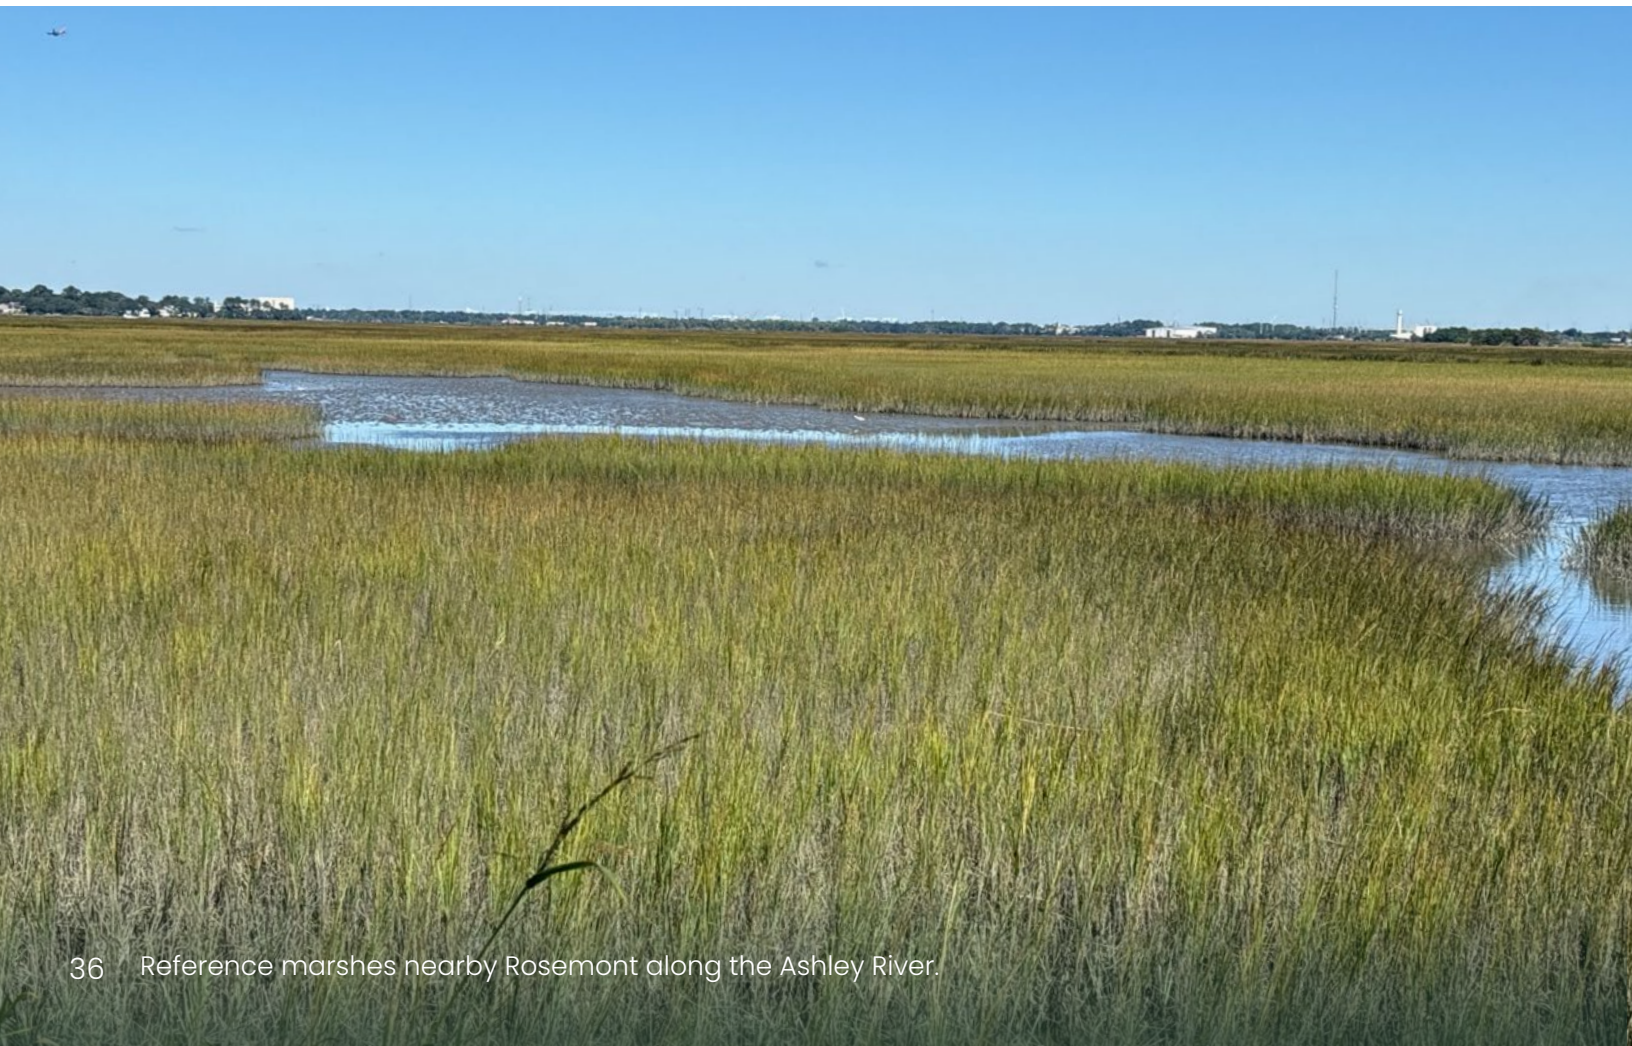
Figure 7

Migration Potential Score

The Rosemont marsh also received a “migration potential score” of 1.0 out of 10.0, with zero percent of the area capable of migrating landward as sea levels rise. One way that healthy marshes can keep pace with sea level rise by gradually shifting to higher ground. The Rosemont marsh is completely surrounded by roads, buildings, and infrastructure, leaving it nowhere to go as water levels become higher in the future. Without intervention, this could mean that the marsh will shrink over time and eventually become open water.

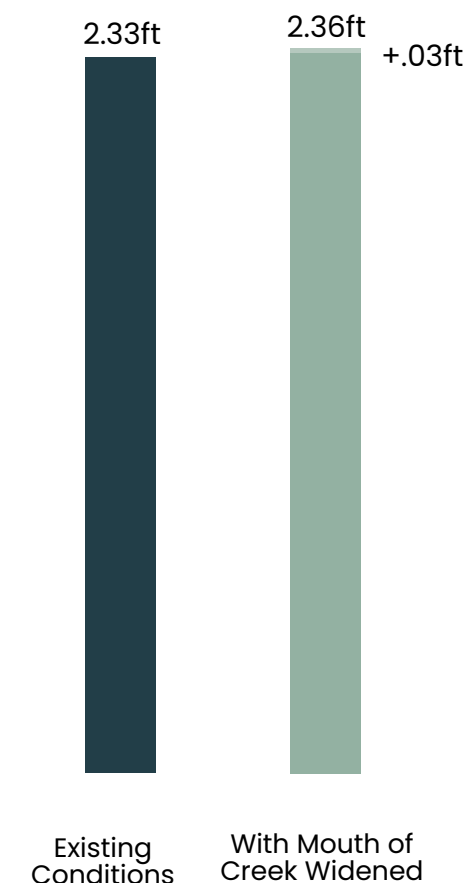
Figure 16: Modeled depth of water on marsh before and after widening the mouth of the creek

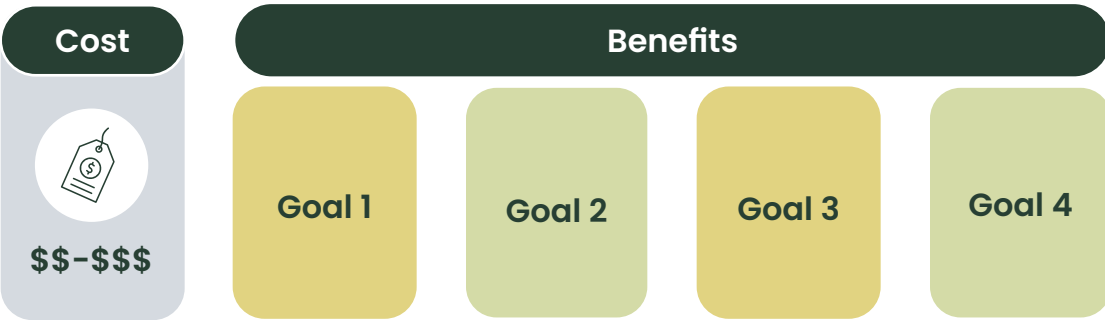
Figure 21: Opportunities for Runnels

**Application:** Runneling works best in areas where the marsh interior is ponded, and where that ponded area sits at a higher elevation than the nearby tidal channel it would drain into. Shallow channels are dug or compacted into the marsh surface in a way that mimics natural drainage patterns, connecting the ponded area to a tidal channel so water can drain more effectively. Shallower excavation within the root zone may offer a shorter-term fix, while deeper excavation below the root zone tends to be more permanent. Material removed during excavation can be placed nearby in shallow, low-profile mounds, sometimes called hummocks, which should stay inconspicuous and never rise above the highest astronomical tide (HAT) level.

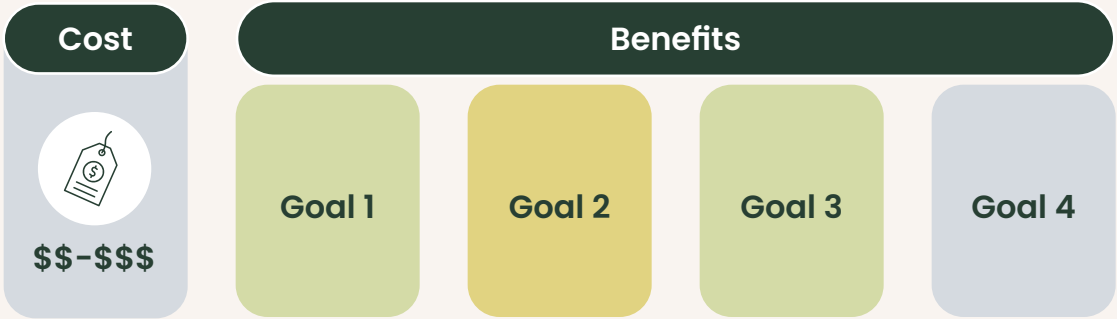
Figure 23: Enterococcus Sampling

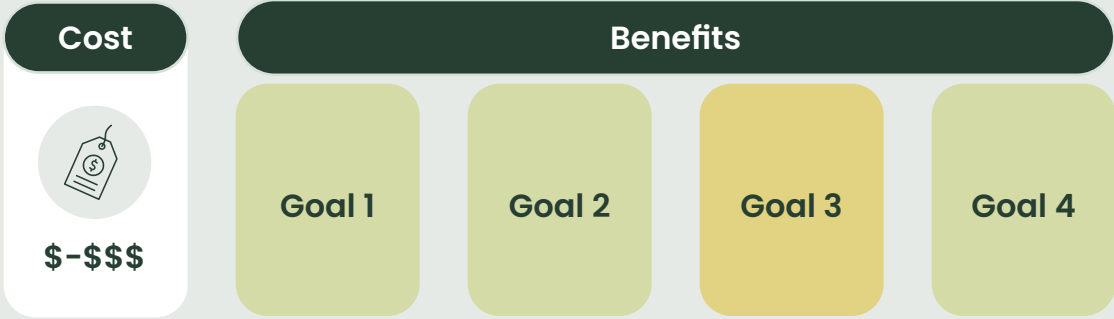
Figure 26: Buffer Management Area around the marsh. This figure depicts a 30 meter buffer from the marsh edge.

- 1. Vegetation management includes controlling non-native invasive species, supplemental planting with native vegetation, and targeted pruning of overhanging vegetation, all aimed at improving existing buffer condition and supporting marsh health.
- 2. Removing impediments includes removing structures and impervious cover to restore the ground’s ability to absorb and filter water.
- 3. Establish a setback line for all properties around the marsh, with future restrictions on building impervious cover or other infrastructure.

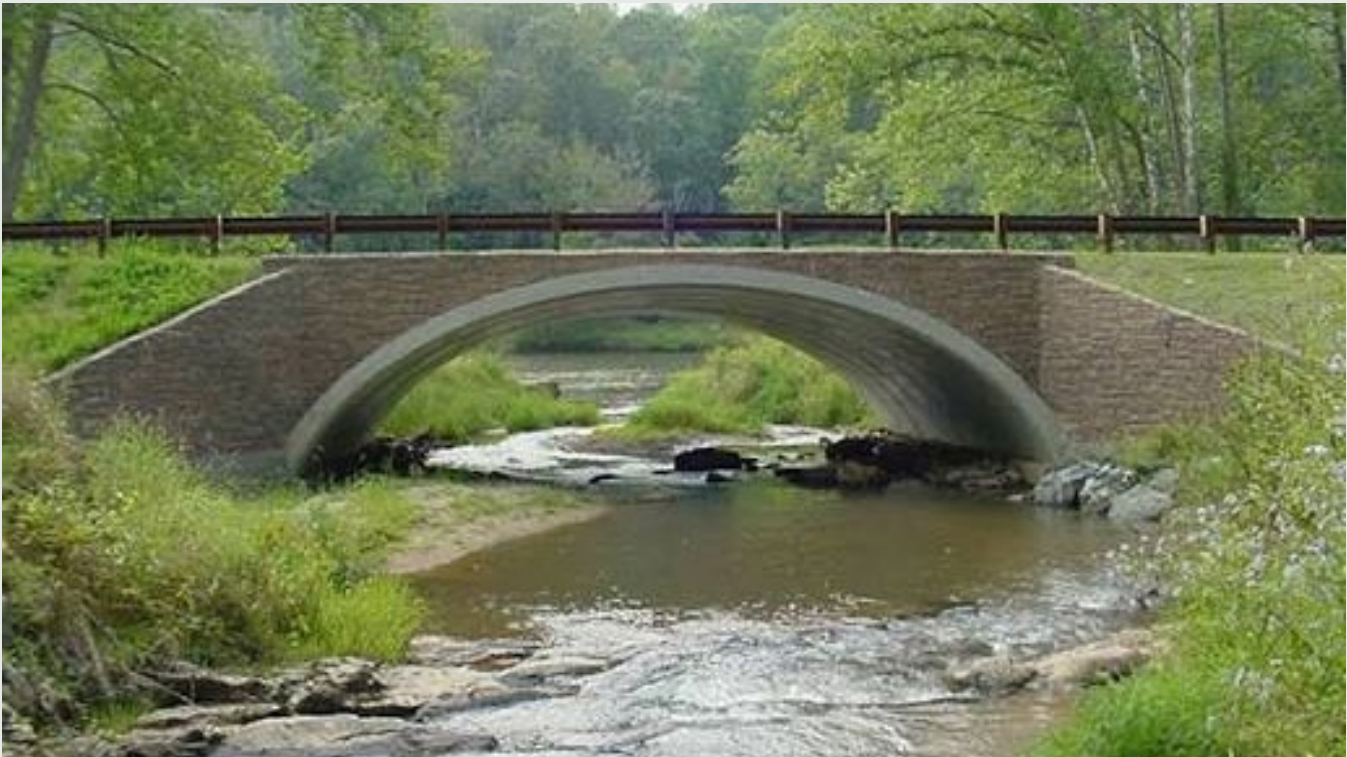
Proposed Condition, Credit: NCDEQ

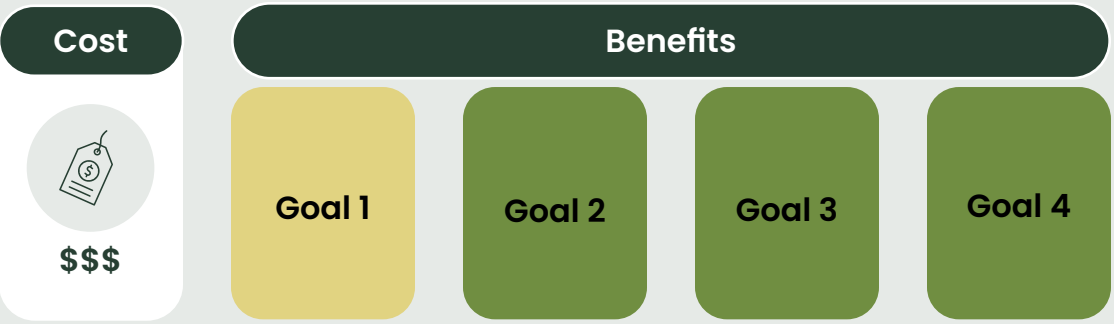
Figure 29: Opportunities for oyster-based living shorelines.

**Application:** For Rosemont, oyster-based living shorelines should be strategically sited to encourage strong oyster growth and maximize both water quality and sediment accretion benefits. The proposed approach uses a somewhat unique reef shape that has shown success in other regions.

In addition to placement within the main marsh channel, living shoreline or oyster growing material can also be installed along the Ashley River-facing edge of the marsh, where wave energy from the open river is more likely to be actively eroding the marsh edge. In this location, the reef structure would primarily serve to reduce erosion and hold sediment in place, helping protect the marsh's outer boundary while providing many of the same water quality and habitat benefits found elsewhere in the system.

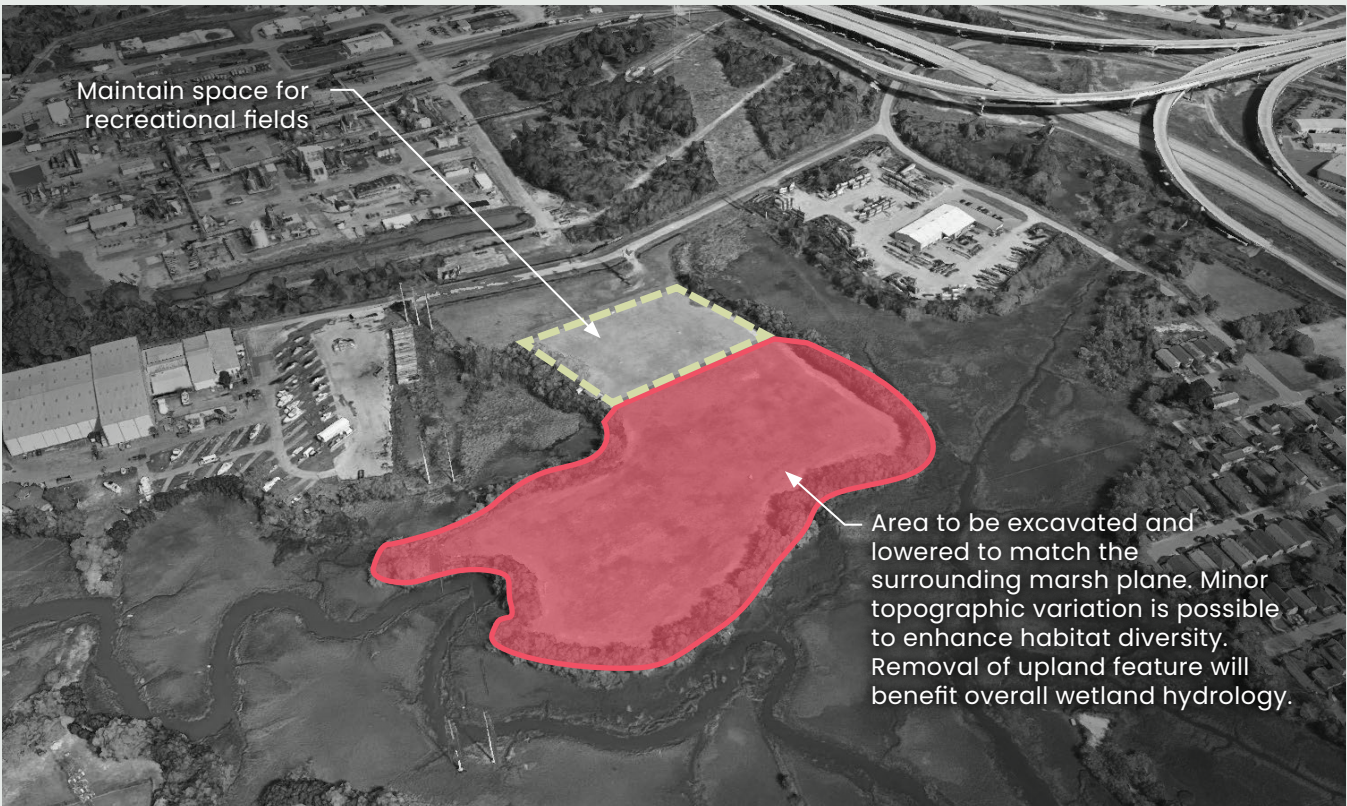
Figure 30 and Figure 31: Opportunities for marsh buffer establishment.

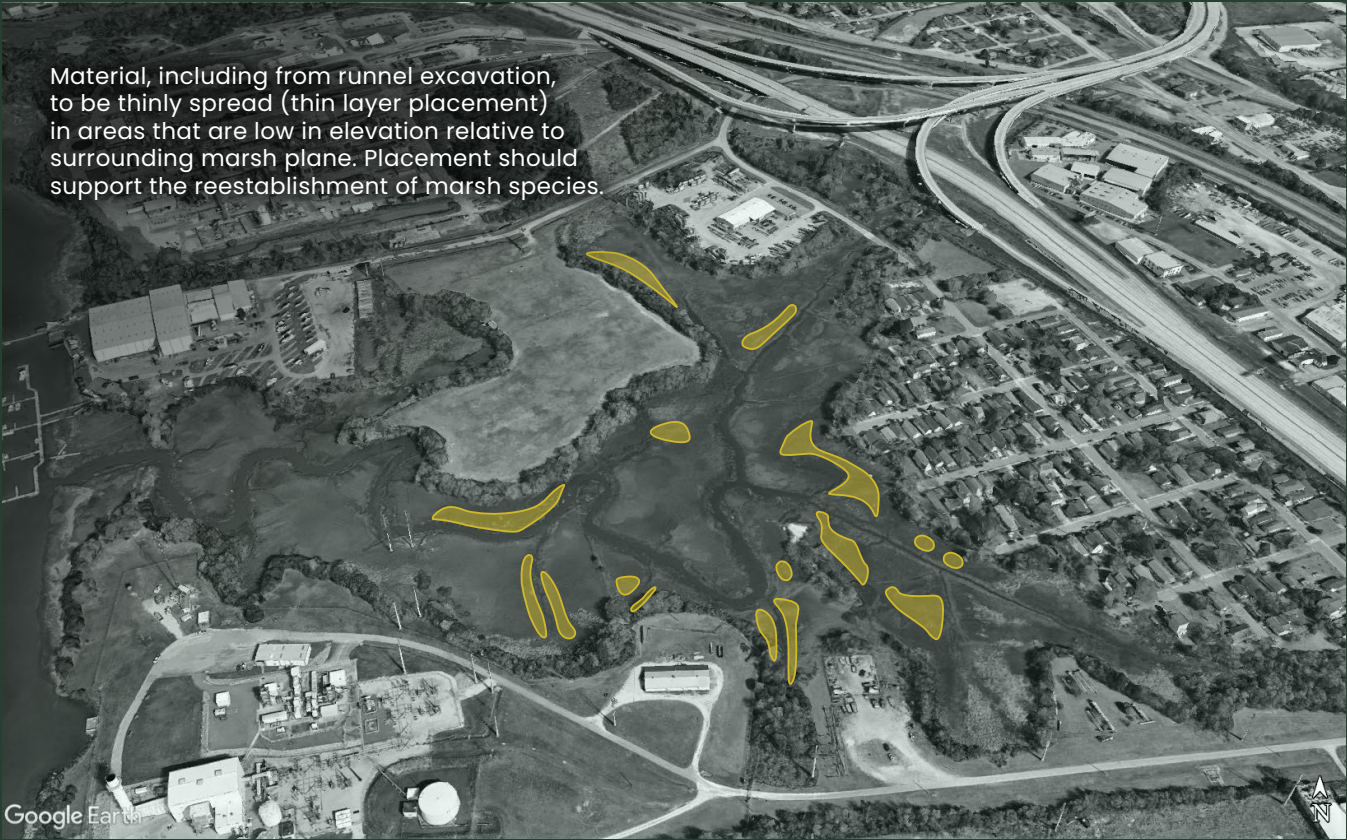
Figure 32: Opportunities for thin layer placement

**Application:** Depending on the level of degradation and the specific goals of a project, thin layer placement can involve anywhere from a few inches to a couple of feet of material. Because placing material at this scale is disruptive to the marsh ecosystem, recovery can take several years, so it's important to plan around the site's specific sea level rise threat and expected recovery timeline when setting elevation targets. A common approach is to use a 10-year planning horizon, accounting for roughly 2 to 3 years of recovery followed by about 7 years of stability. To help offset the short-term loss of marsh function during recovery, project teams can also designate management units, tracts of marsh intentionally preserved in a high-functioning state throughout the restoration timeline. Long-term planning also allows a TLP project to be timed around the local availability of suitable dredge material, improving cost efficiency. One strategy for this, called Beneficial Use of Dredge Material (BUDM), aligns TLP projects with already-planned dredging work, so the cost of placing material is covered as part of that separate dredging effort rather than as a standalone expense.

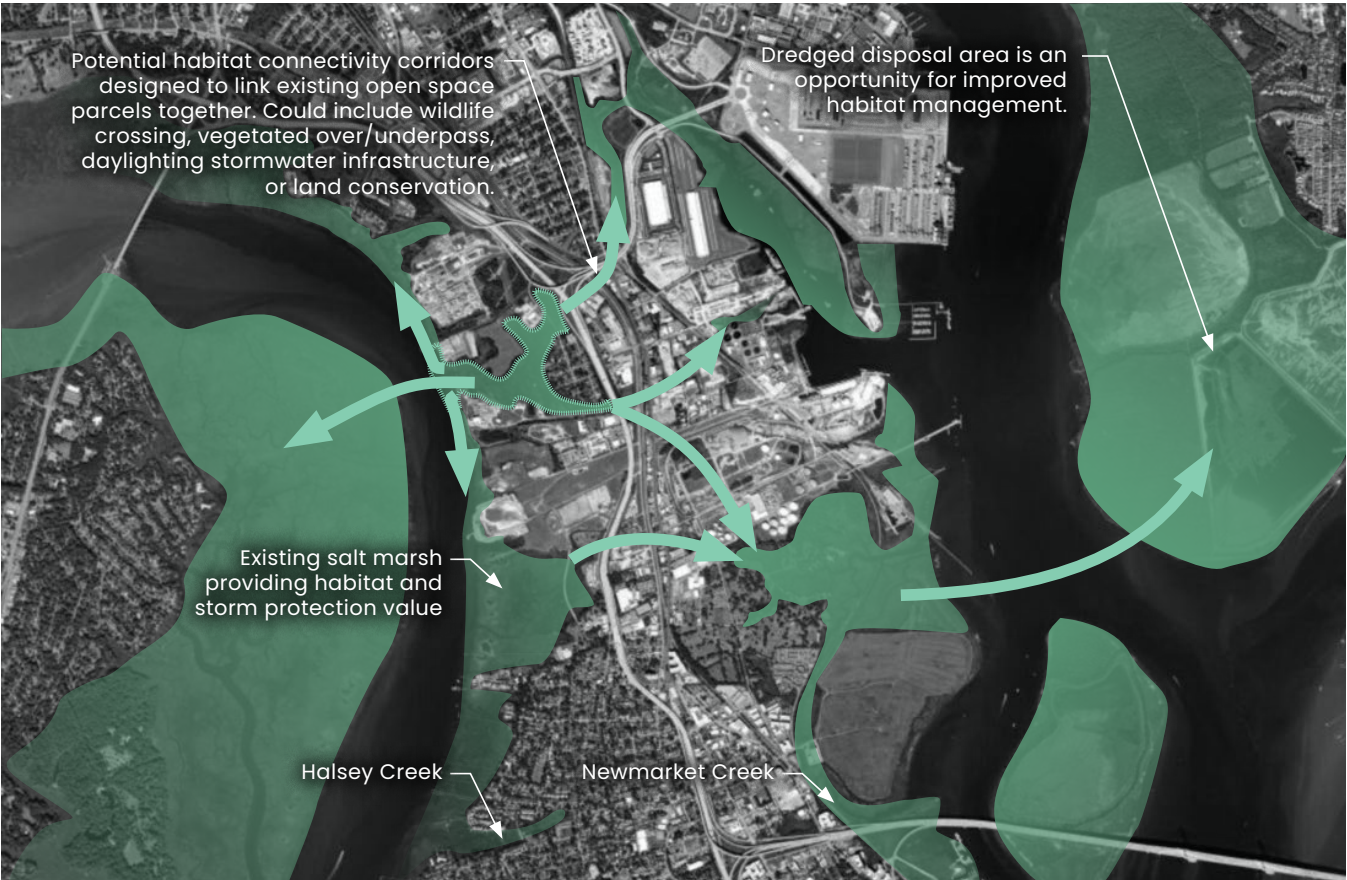
Figure 33: Opportunities for improved habitat connectivity.

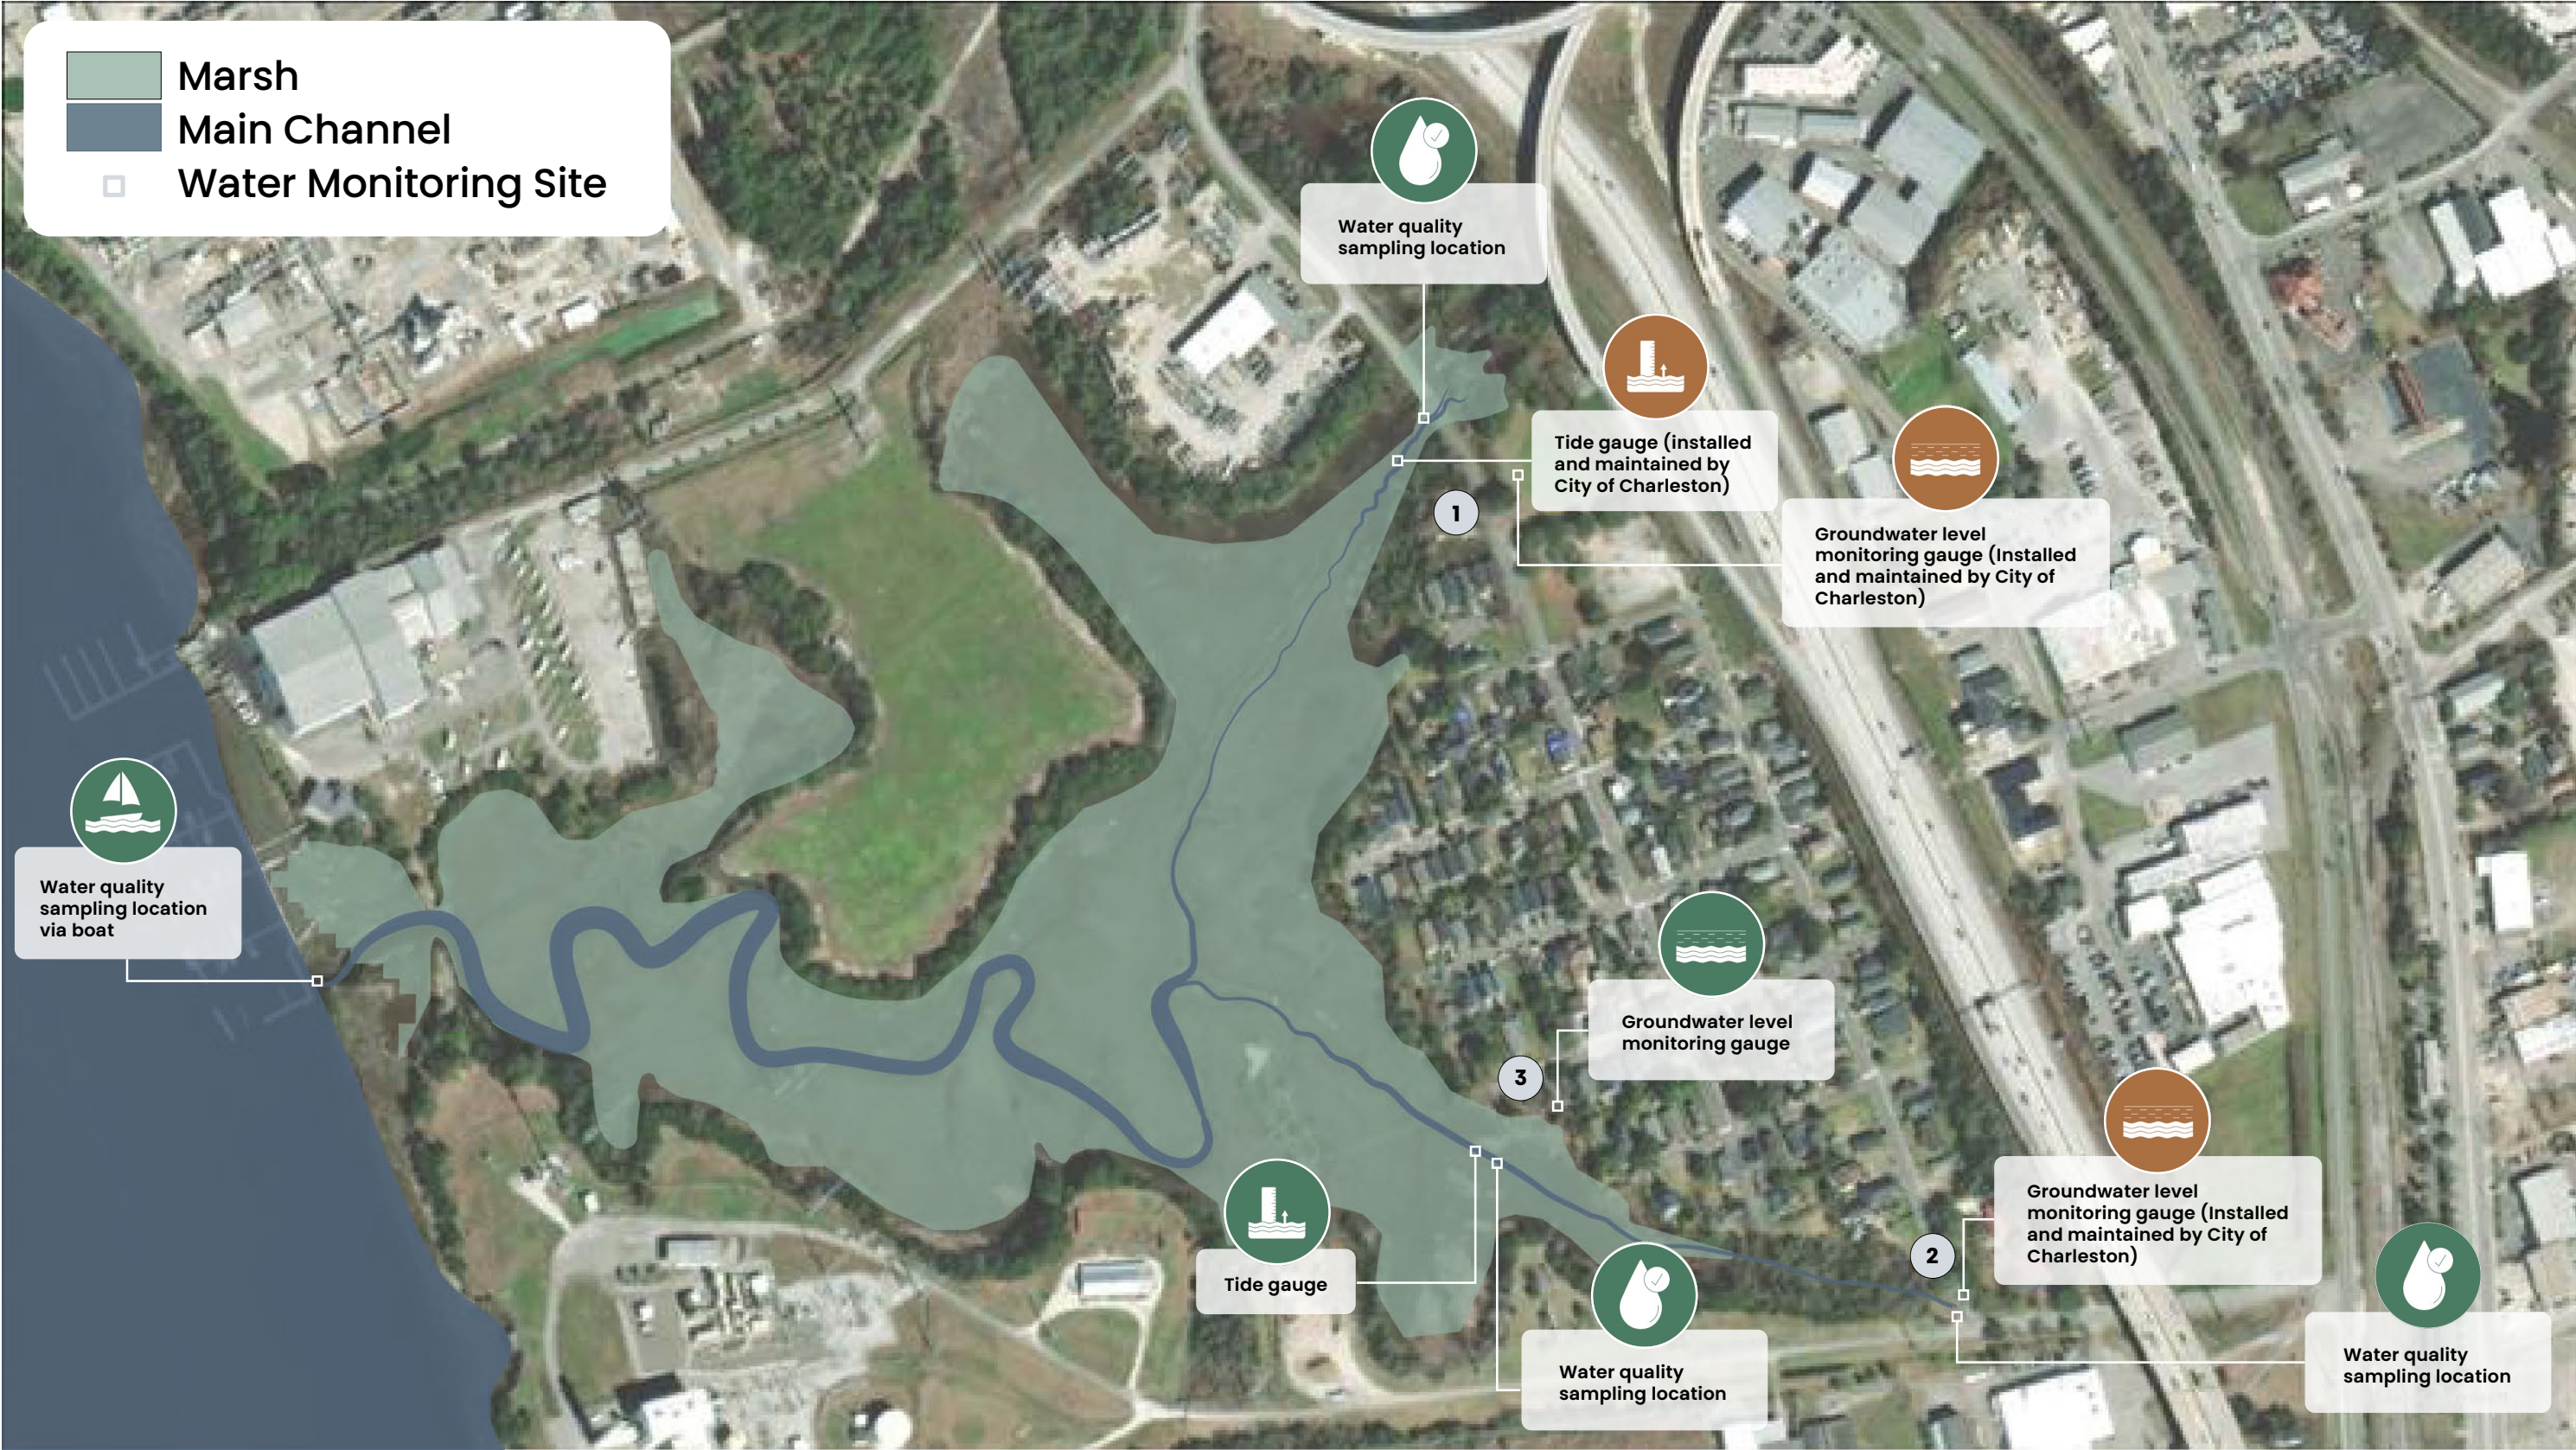
Marsh Monitoring Locations

Samples will be taken from three, possibly four (pending landowner approval for access), locations around Rosemont, as identified on Map 1:

- Austin Avenue bridge (Site 1)
- Freddie Whaley Community Center culvert (Site 2)
- Odessa Street (Site 3)
- Boat Sampling Site

This monitoring plan includes multiple field sampling locations in and around the Rosemont tidal wetland. Map 1 at the beginning of this section shows the distribution of water quality sampling locations, as well as the locations of existing and newly installed (as of 2025) groundwater wells and tide level loggers. While groundwater level and tide level data are not part of this water quality monitoring effort, those instruments are noted here because data will be downloaded during the same field visits for logistical efficiency.

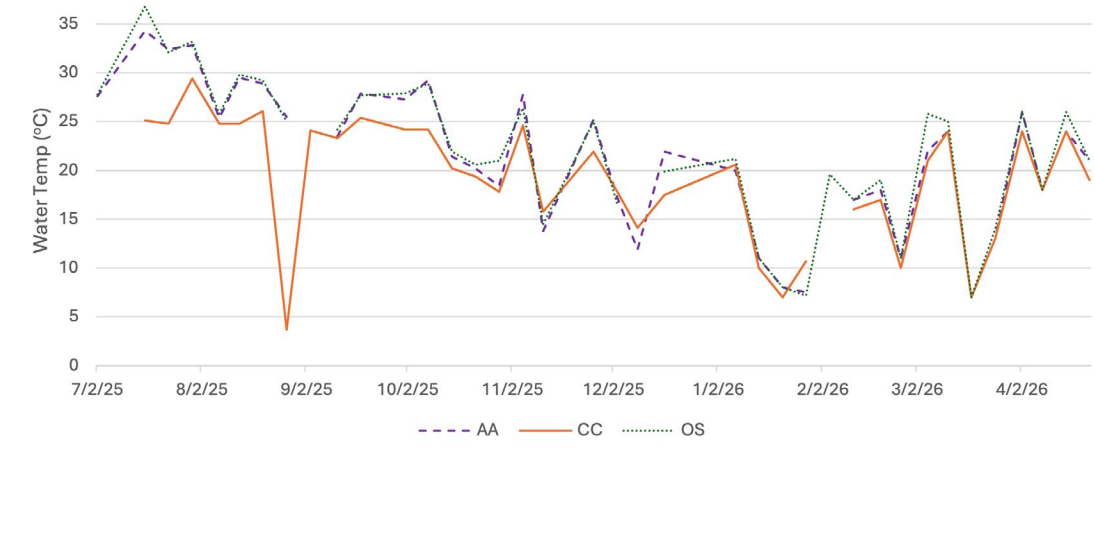
Water temperature at the Community Center location has generally lower temperatures than the other two sites, with an overall average of 19.2oC compared to 21.4oC at Austin Avenue and 22.0oC at Odessa Street.

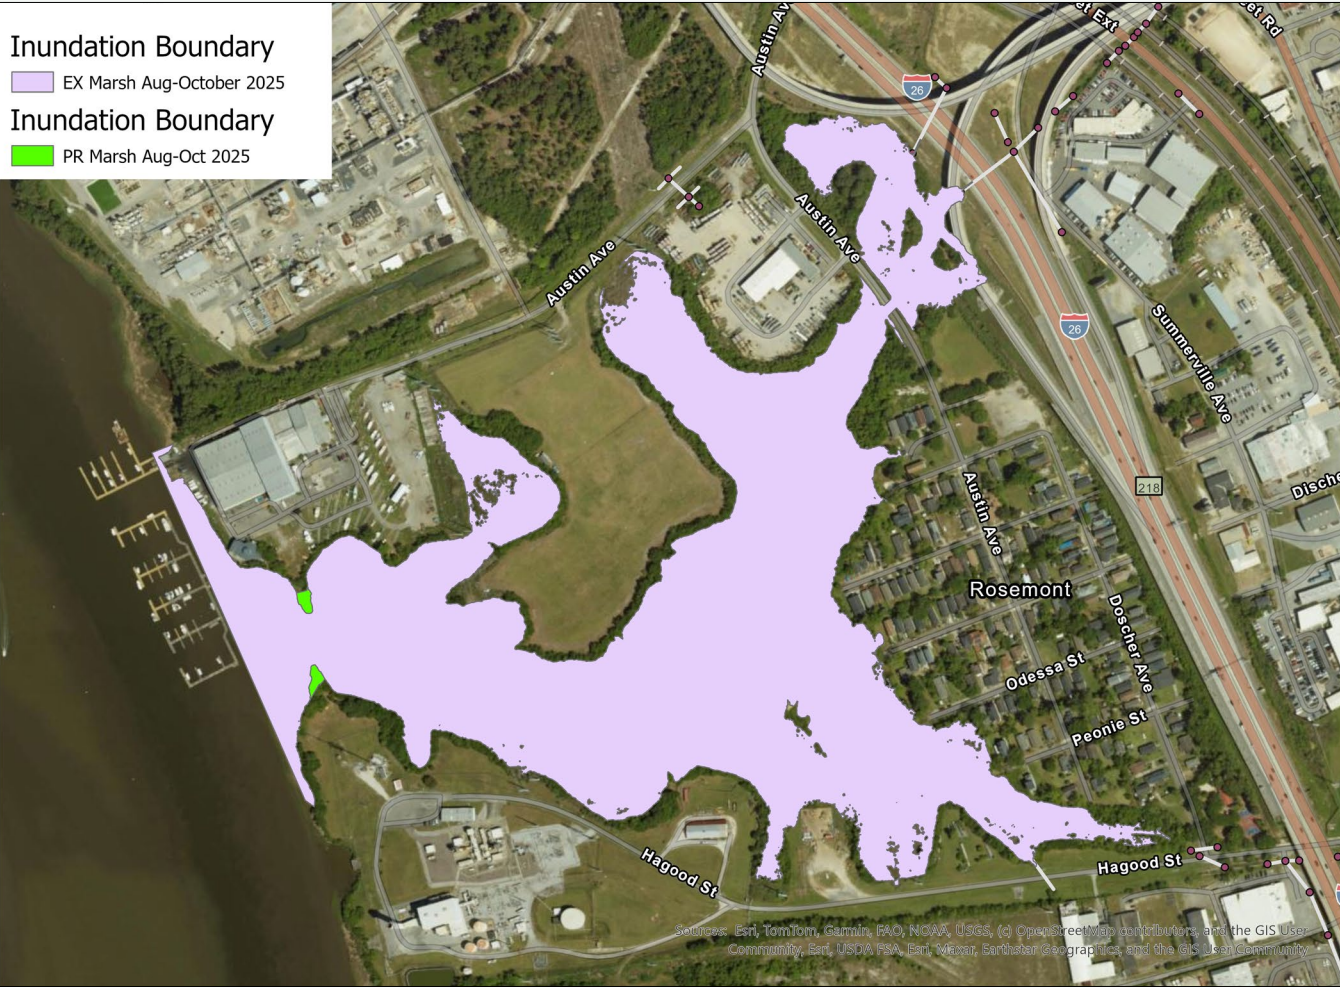
PR Marsh Aug-Oct 2025

Inundation Boundary

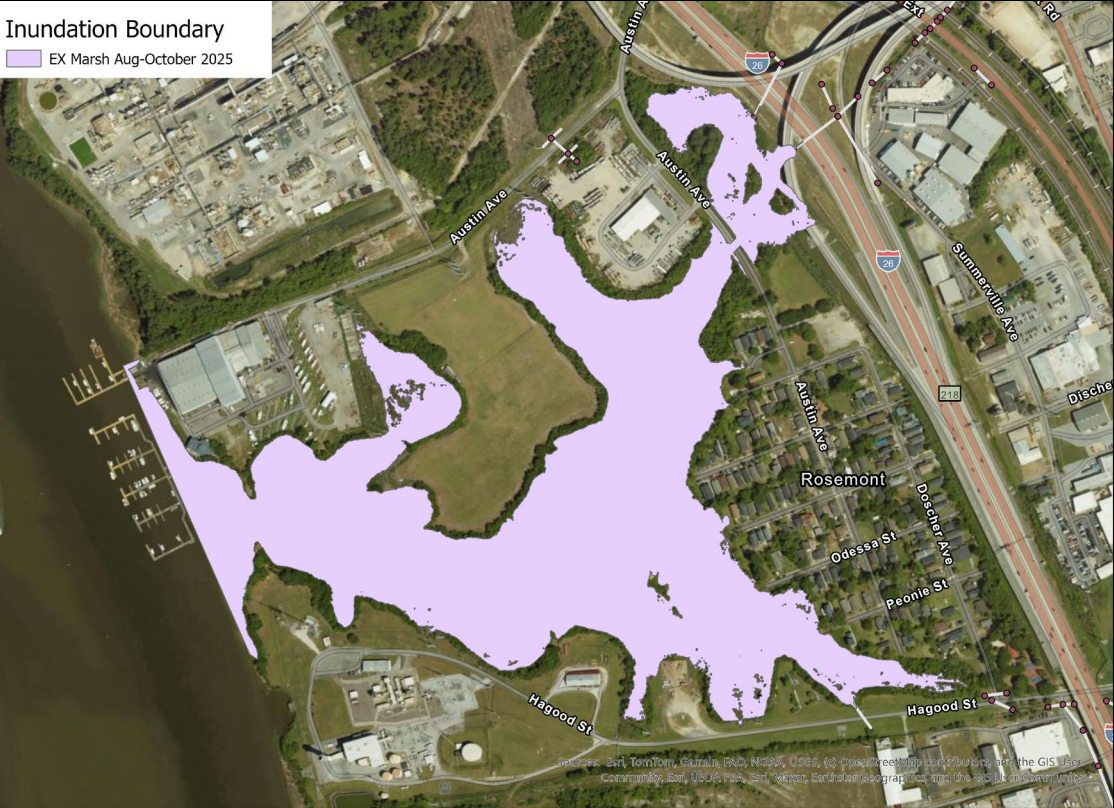
EX Marsh Aug-October 2025

Inundation Boundary

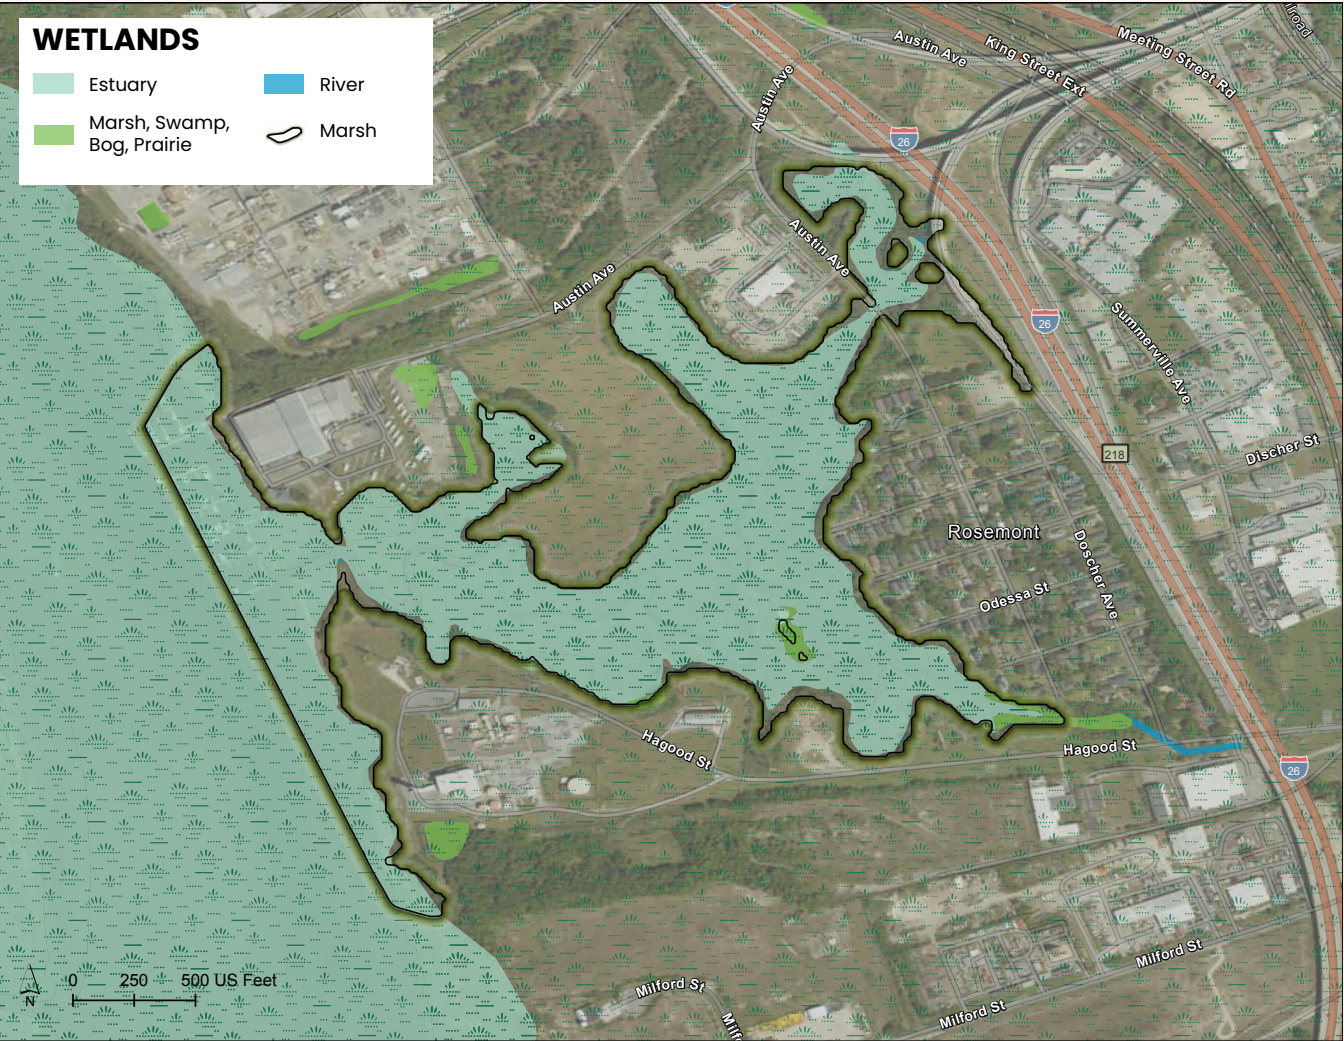
### Normalized Different Vegetation (NDVI) Analysis:

The team conducted a NDVI mapping analysis on ArcGIS Pro to visualize historic patterns of vegetation gain or loss in the Rosemont marsh. This marsh condition analysis was conducted using Sentinel-2 satellite imagery to identify current degradation and restoration targets. Sentinel-2 provides 10-meter resolution, enabling analysis of individual creek edges and small degraded patches that would be invisible at coarser scales. Comparing 2018–2020 and 2022–2024 growing seasons in Google Earth Engine, the analysis combines measured Normalized Difference Vegetation Index (NDVI) change, Normalized Difference Red Edge Index (NDRE) stress, and water expansion into a single 0–3 restoration priority score per pixel:
